Archaeological Test Trenching Investigations Report

at Dalcassian House, Island Road, Limerick City

Licence No.: 06E0125

March 2006

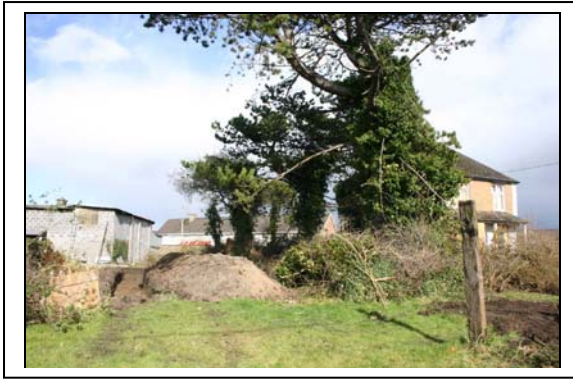
Plate 1. General view of trench 1 and existing house,
from south

This trench was situated to the eastern side of the site and was aligned approximately from northeast to southwest. It was 21m in length and 1.80m wide. The trench was excavated to a maximum depth of 1m, with the fill consisting primarily of topsoil with inclusions of rubble throughout. At 11.70m from the northeastern end of the trench there was a lens of mortar approximately 3m in length and 0.05m deep. This was approximately 0.20m from the end of the trench. At 15.70m from the northeastern end of the trench there was a layer of tarmac approximately 5.30m long at 0.70m from the base of the trench. Three features were noted in this trench.

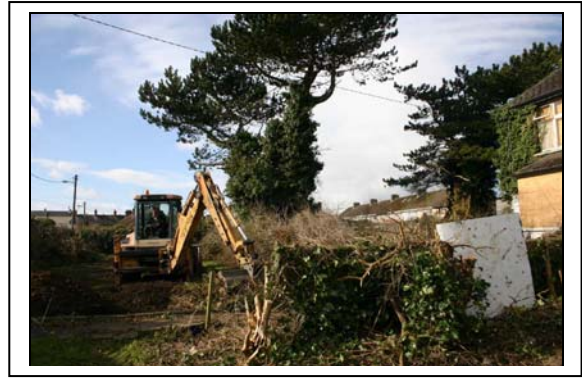
Plate 2. Excavation of trench 2, from east

This trench was 15m in length and was aligned approximately from northwest to southeast across the southern part of the site. It was 1.80m wide and was 0.75m deep on average. The general stratigraphy consisted of approximately 0.55m of topsoil with rubble inclusions. Beneath this there was approximately 0.20m of more concentrated rubble and mortar. Four possible features were noted in this trench.

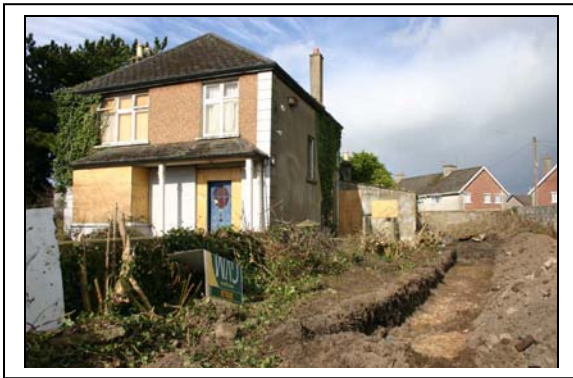
Plate 3. Trench 3, from south

This trench was 14m in length and ran approximately from northeast to southwest across the eastern part of the site. The trench was approximately 0.60m deep and contained topsoil with inclusions of rubble throughout. Three features were identified in this trench.

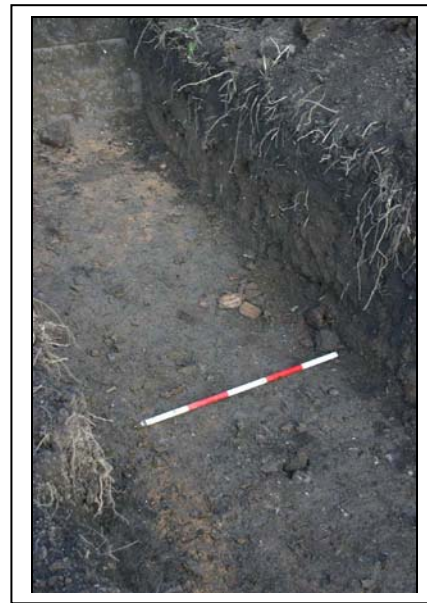
[Context 2] This was located 1.60m from the northeastern end of the trench and was approximately 2.10m long. Its full extent could not be determined as it continued outside the trench to the east and west. It contained a dark greyish brown fill, with frequent fragments of post-medieval pottery (06E0125:2:1).

Plate 4. [c. 2] in trench 1, from southwest

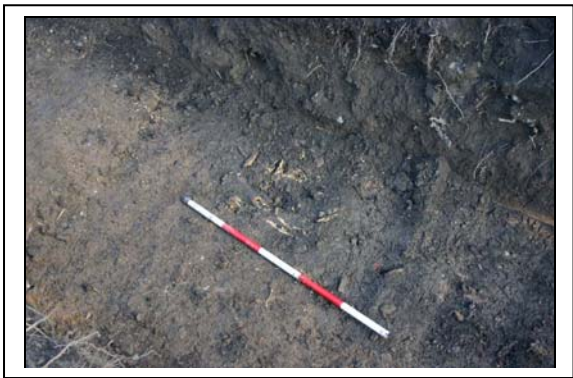
[Context 3] This linear feature ran across the trench approximately from northeast to southwest. It was visible at 6.50m from the northeastern end of the trench for approximately 6.50m, at which point it ran beneath the western baulk of the trench. It contained a mid greyish brown fill with frequent animal bone (06E0125:3:1).

Plate 5. Animal bone in [c. 3] in trench 1, from west

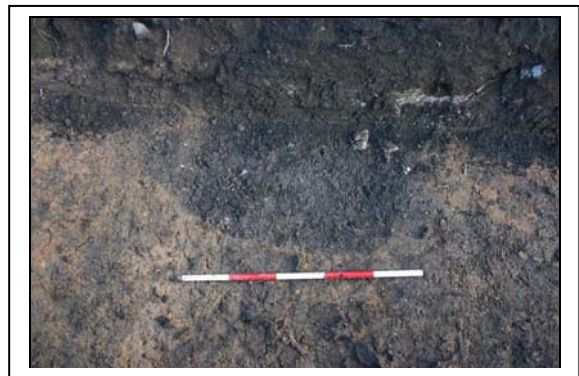
[Context 4] This was visible running beneath the eastern baulk of the trench at approximately 13.50m from the northeastern end of the trench. It had a maximum visible length of 1m and contained a dark brownish grey fill with occasional inclusions of flecks of charcoal, fragments of animal bone and small stones (06E0125:4:1).

Plate 6. [c. 4] in trench 1, from northwest

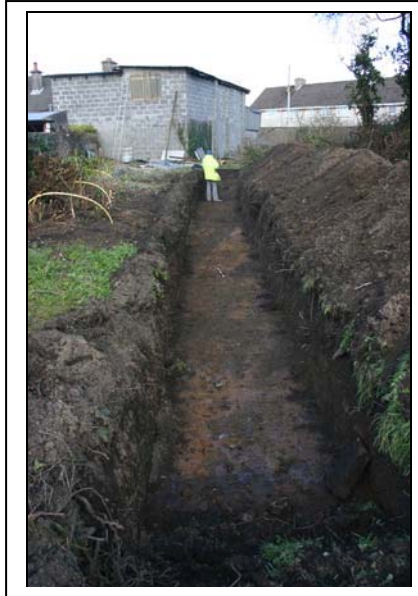
Plate 7. General view of trench 1,
from southwest

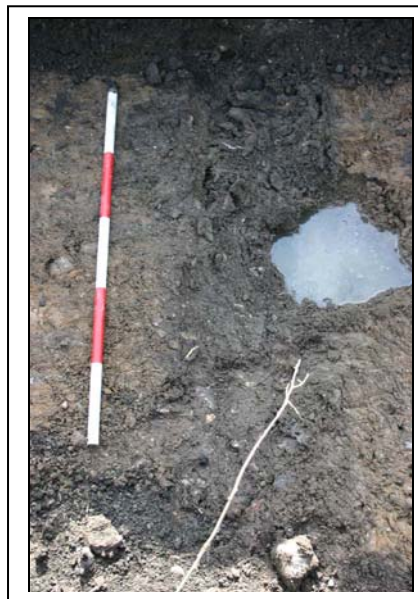
[Context 6] This was a linear feature approximately 0.40m wide, which ran across the trench from northeast to southwest. It was situated 5.20m from the southeastern end of the trench.

Plate 9. [c. 6] in trench 2, from
southeast

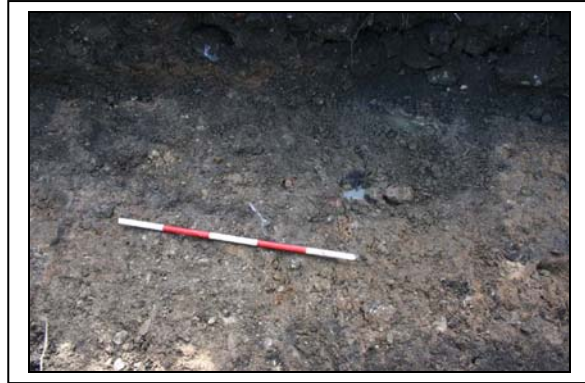
[Context 5] Approximately 2.20m from the southeastern end of the trench there was a patch of dark brownish grey gravelly clay. This was approximately 2m in length and it extended approximately 0.60m out from the southern baulk of the trench. There were inclusions of mortar, brick, animal bone and pottery in this context (06E0125:5:1).

Plate 8. [c. 5] in trench 2, from north

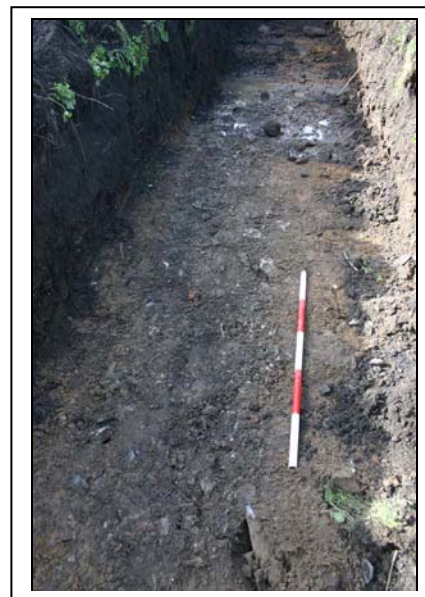
[Context 7] This was a linear feature, which ran along the middle of the trench from approximately 5.60m to 9.60m. It may have been connected to [c. 6] and [c. 8]. It had a maximum width of 0.50m and contained fragments of brick, mortar, modern pottery and glass throughout the fill ((06E0125:7:1).

Plate 10. [c. 7] in trench 2, from southeast

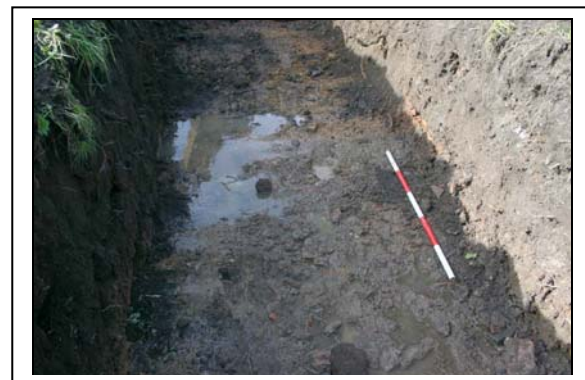
[Context 8] This linear feature was located approximately 9.60m from the southeastern end of the trench and was approximately 2m wide. It ran across the trench from northeast to southwest and may have been related to contexts [c. 6] and [c. 7]. This feature may have been a trench for a sewerage pipe.

Plate 11. [c. 8] in trench 2, from southeast

A linear feature identified in trench 2 may be of modern date, (context [c. 8] because of the presence of fragments of sewer pipe) while contexts [c.6] and [c.7] may also be associated modern features. However, features [c. 2], [c. 3] and [c. 4] in trench 1, [c. 5] in trench 2 and [c. 9], [c. 10] and [c. 11] in trench 3 appear to be archaeological in nature.

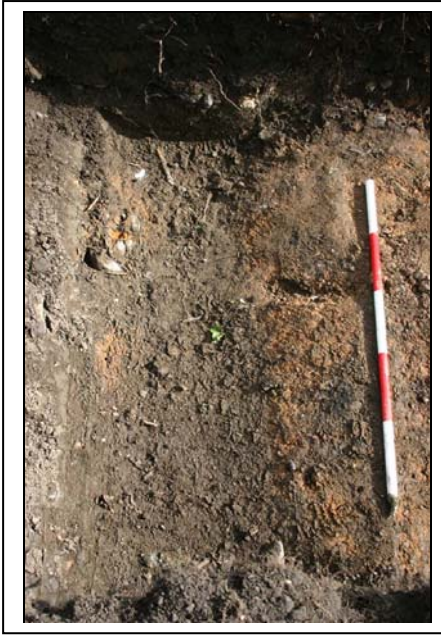
[Context 9] This was situated at the northeastern end of the trench and extended approximately 0.50m into the trench. It contained a dark grayish brown fill with occasional flecks of charcoal and fragments of animal bone (06E0125:9:1).

Plate 12. [c. 9] in trench 3, from
northwest

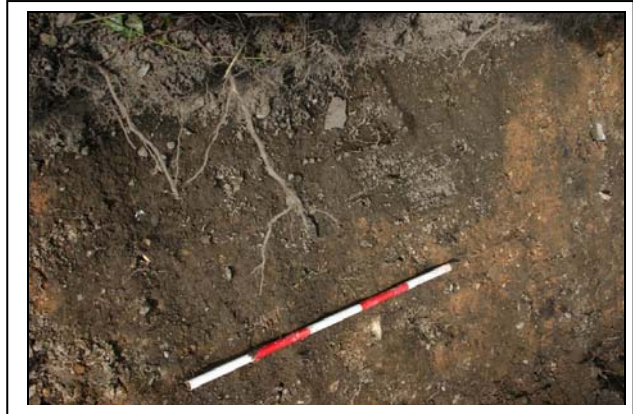
[Context 10] This was situated in the western baulk of the trench at approximately 2.60m from the northeastern end of the trench. It was 1.80m in length and had a maximum width of 0.80m. It was an irregularly shaped feature with evidence of root activity throughout. The fill was dark grayish brown with fragments of animal bone and oyster shells in it (06E0125:10:1).

Plate 13. [c. 10] in trench 3, from southeast

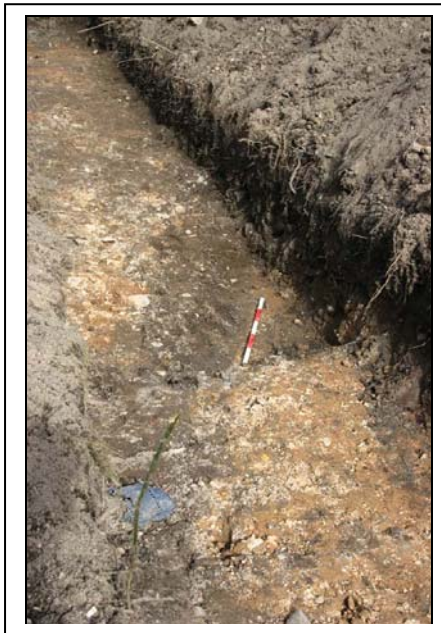
[Context 11] This was a linear feature, which ran approximately from northeast to southwest across the trench. It was 0.50m wide on average. It had a dark brown silty fill with frequent sherds of pottery throughout it (06E0125:11:1).

Plate 14. [c11] in trench 3, from
southwest

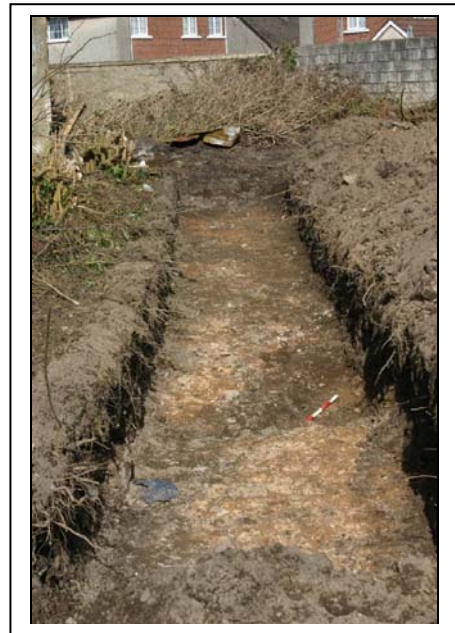
Plate 15. General view of trench 3,
from southwest

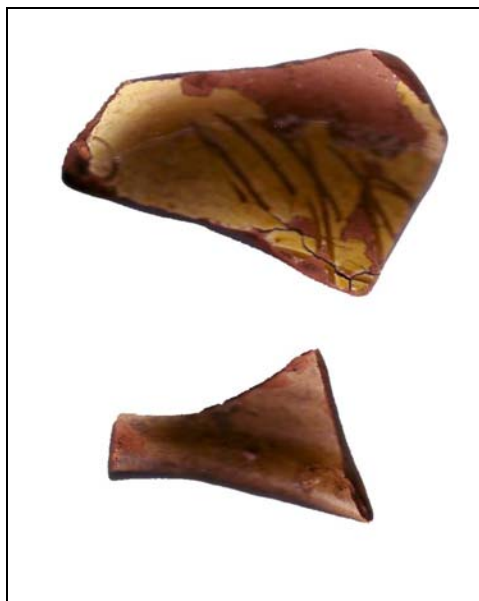
Plate 16. Pottery from Trench 1 (North Devon Sgraffito to top, Glazed Red Earthenware to bottom)
